Geotechnical Study

**GEOTECHNICAL FEASIBILITY INVESTIGATION
AND FAULT RUPTURE HAZARD ASSESSMENT
22330 MAIN STREET
HAYWARD, CALIFORNIA
*SFB PROJECT NO. 648-1***

Stevens, Ferrone & Bailey Engineering Company, Inc.

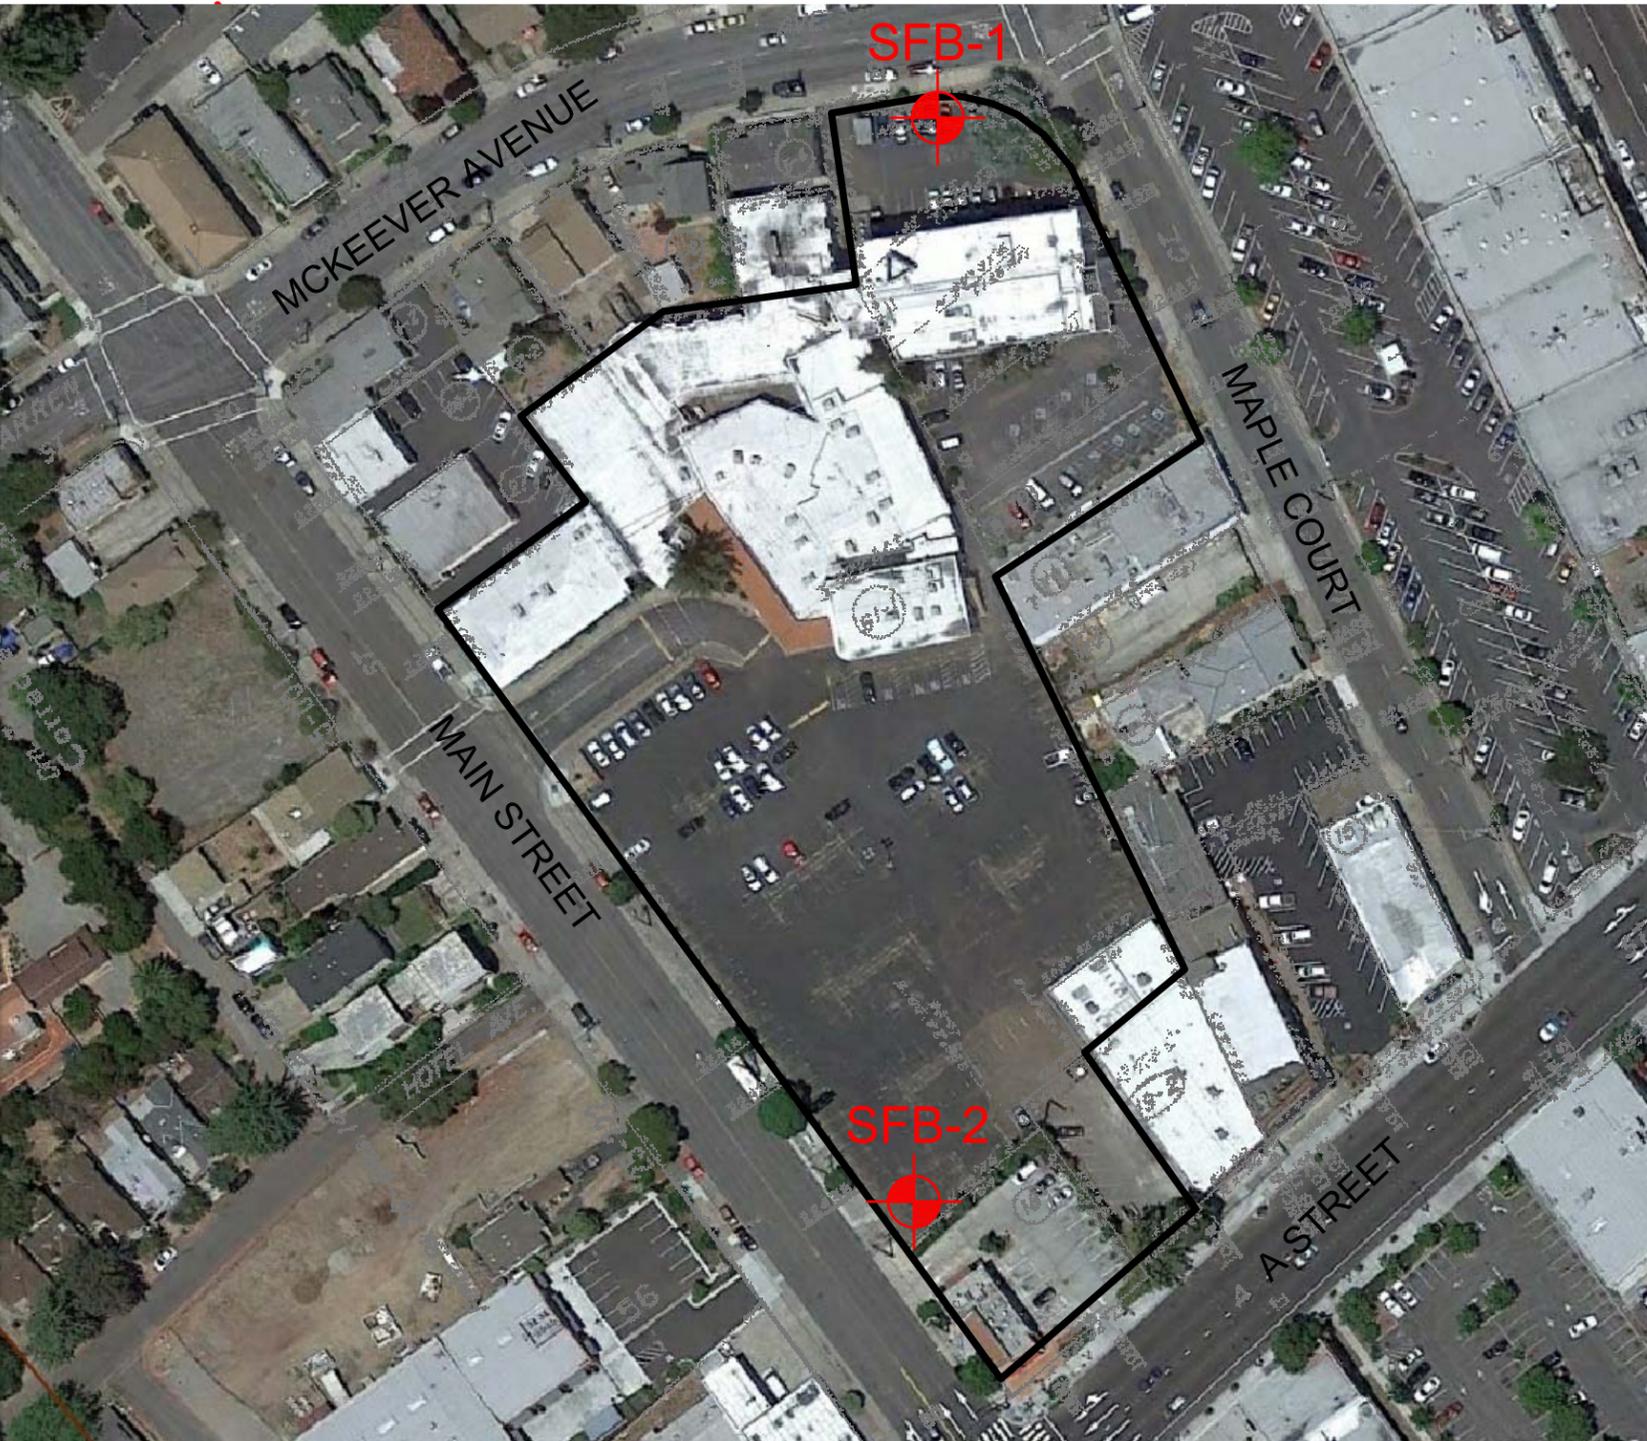
FIGURE
6

SITE PLAN
22330 MAIN STREET Hayward, California

At the time of our investigation, the site was being used as an office complex with associated paved parking, paved access ways, and walkways. Several single- and multi-story buildings occupied the site. Some of the buildings had basements. Landscaped planter areas were also observed. Figure 6 shows the approximate locations of the various existing improvements.
